Automatic Transaxle System

General Information

A5SR2

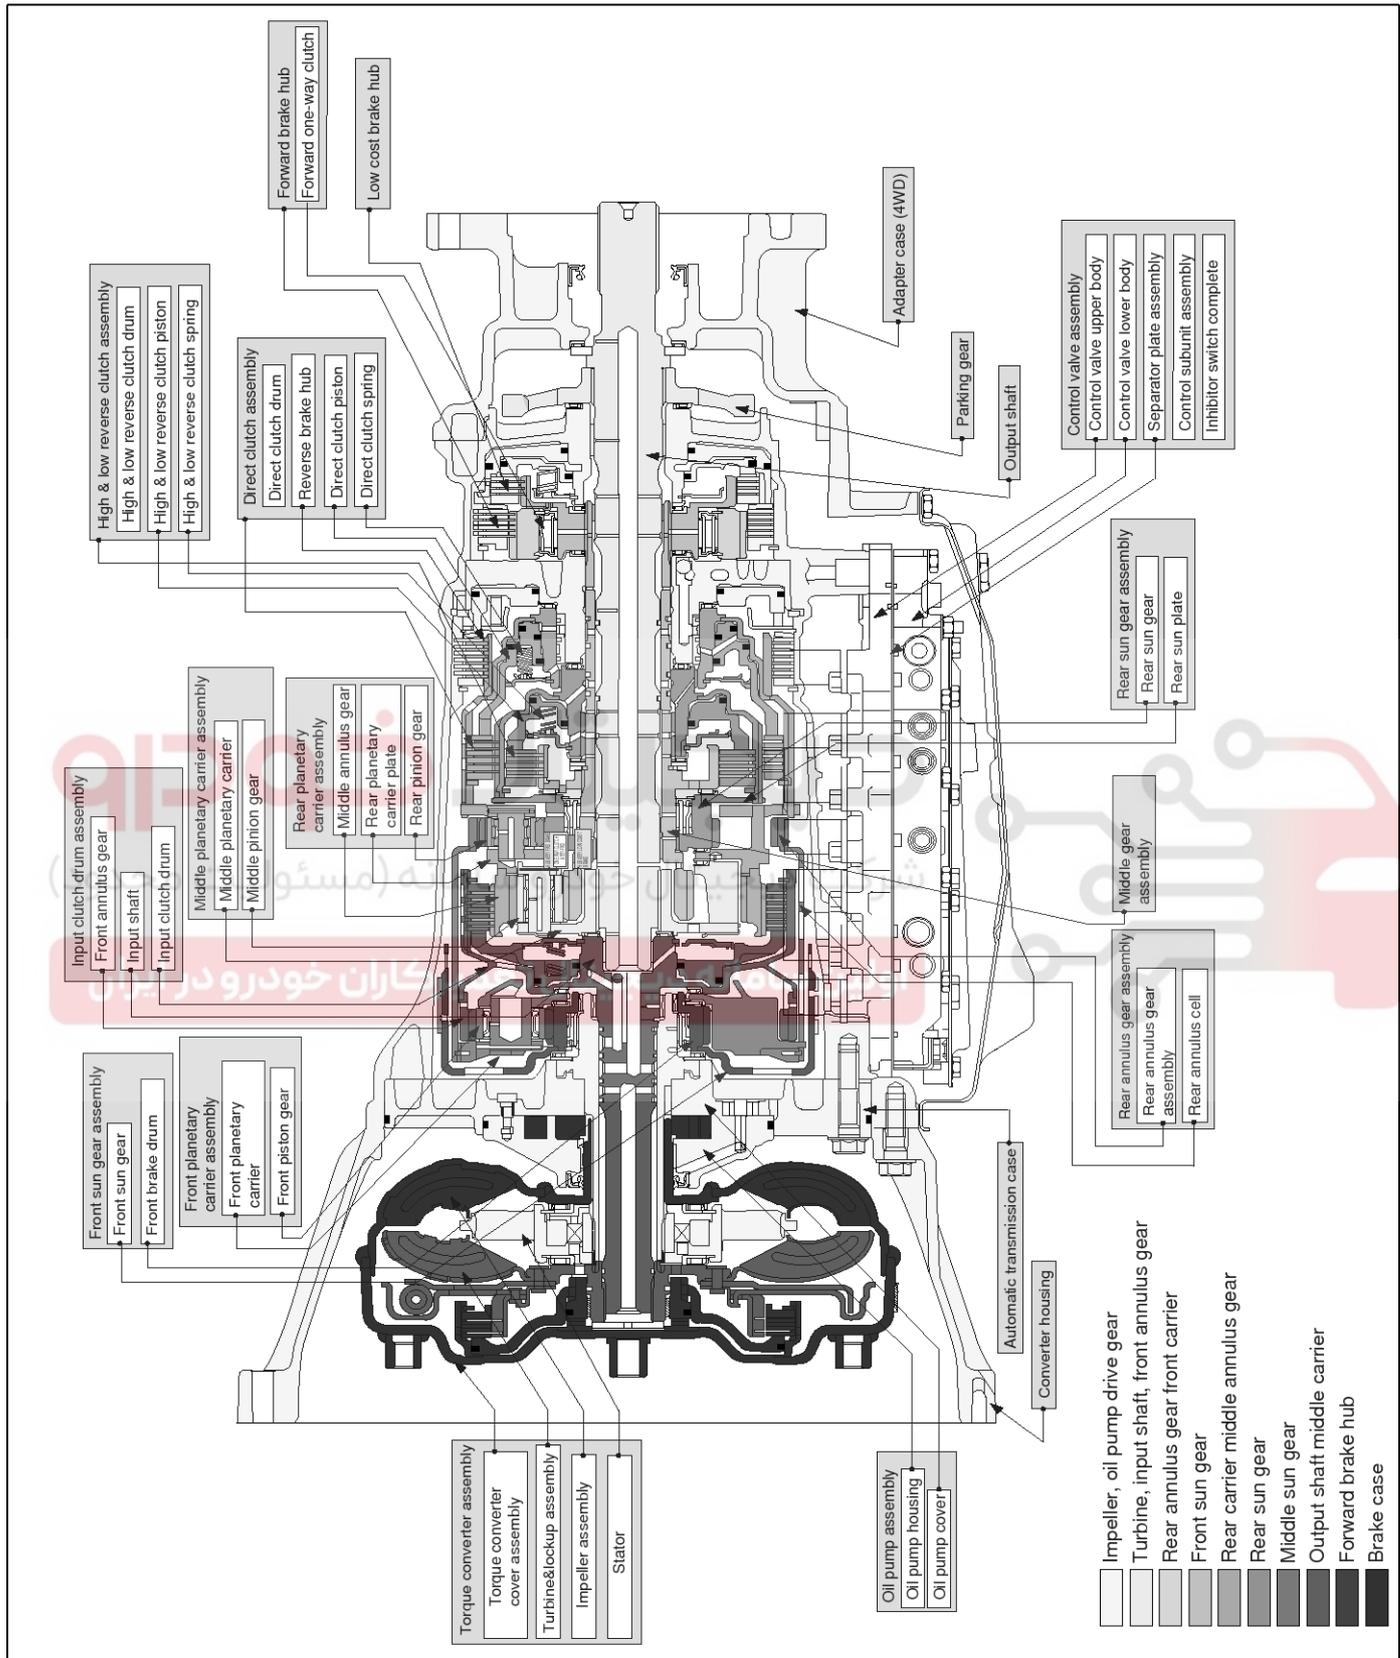
LLAE001A

COMPONENTS

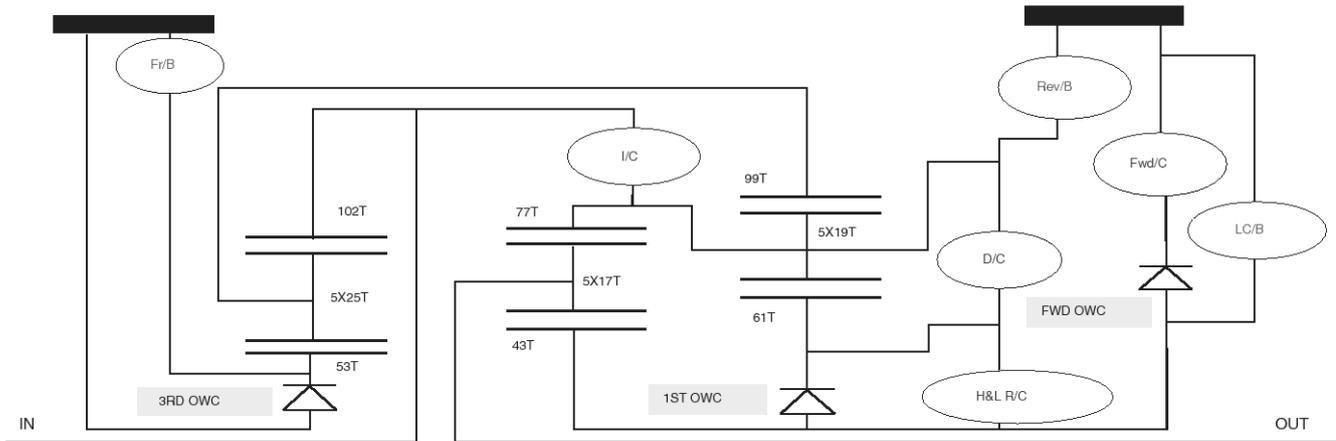
LLAE001B

Shift Position	I/C	H&L R/C	D/C	Rev/B	Fr/B	LC/B	Fwd/B	Ratio1 OWC	Forward OWC	Ratio 2 OWC	Remarks
P		△			△						Parking position
R		0		0	0			⊙		⊙	Reverse position
N		△			△	△'''					Neutral position
D	1st	△"			△		0	⊙	⊙	⊙	Automatic shift 1↔2↔3 ↔4↔5
	2nd		0		△		0		⊙	⊙	
	3rd		0	0		0	△	◇		⊙	
	4th		0	0			△	◇			
	5th		0			0	△	◇		◇	
5M	5th		0		0		△	◇		◇	Fix to the 5th speed
4M	4th		0	0			△	◇			Fix to the 4th speed
3M	3rd		0	0		0	△	◇		⊙	Fix to the 3rd speed
2M	2nd			0		0	0		⊙	⊙	Fix to the 2nd speed
1M	1st				0	0	0	⊙	⊙	⊙	Fix to the 1st speed

- 0 : Operates.
 - ⊙ : Operates during progressive acceleration.
 - ◇ : Operates and effects power transmission while coasting.
 - △ : Line pressure is applied but does not affect power transmission.
 - △" : Operates under conditions shown in the high & low reverse clutch operating condition.
 - △''' : Operates under conditions shown in the LC/B operating condition.
- Note) Delay control is applied during D(4,3,2,1) ⇒ N shift.

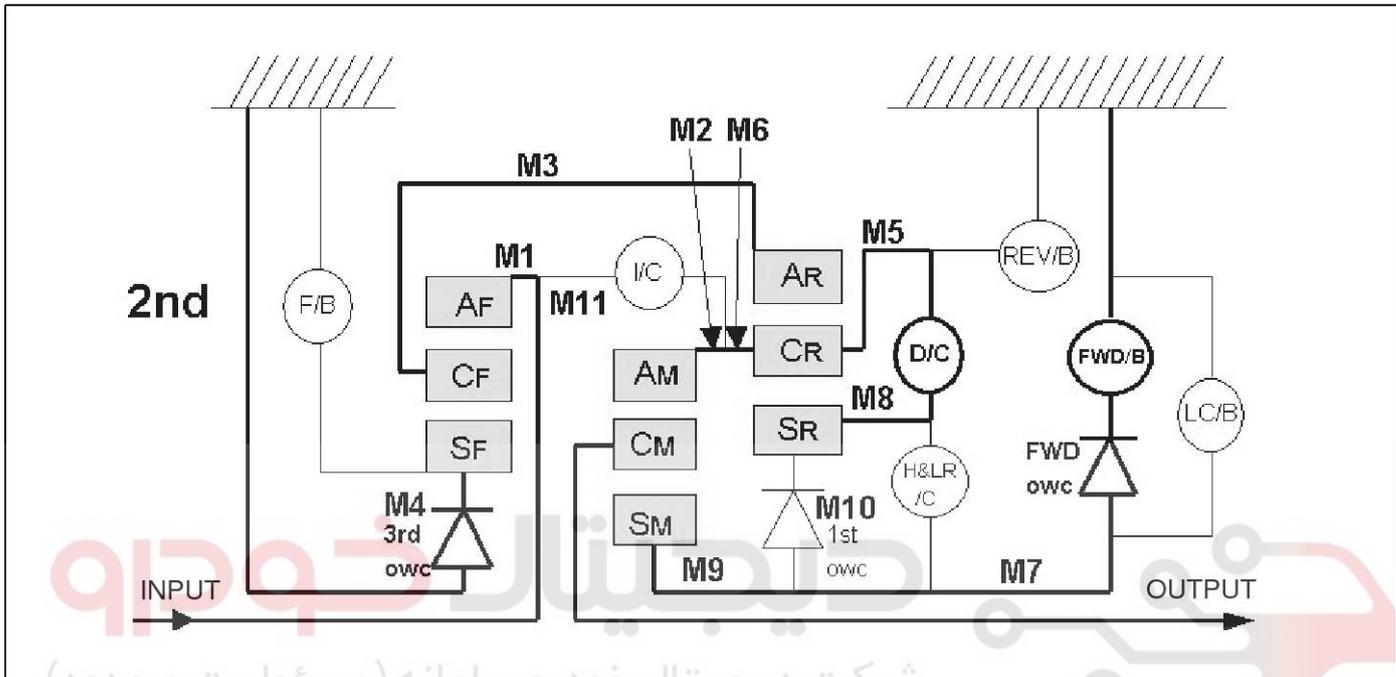
4. D, M3, M4, M5 range ratio 2nd

- Fasten the front brake.
- The front brake and the forward one-way clutch regulate reverse rotation of the mid sun gear.
- The 3rd one-way clutch regulates reverse rotation of the front sun gear.

The direct clutch is coupled and the rear carrier and the rear sun gear are connected.

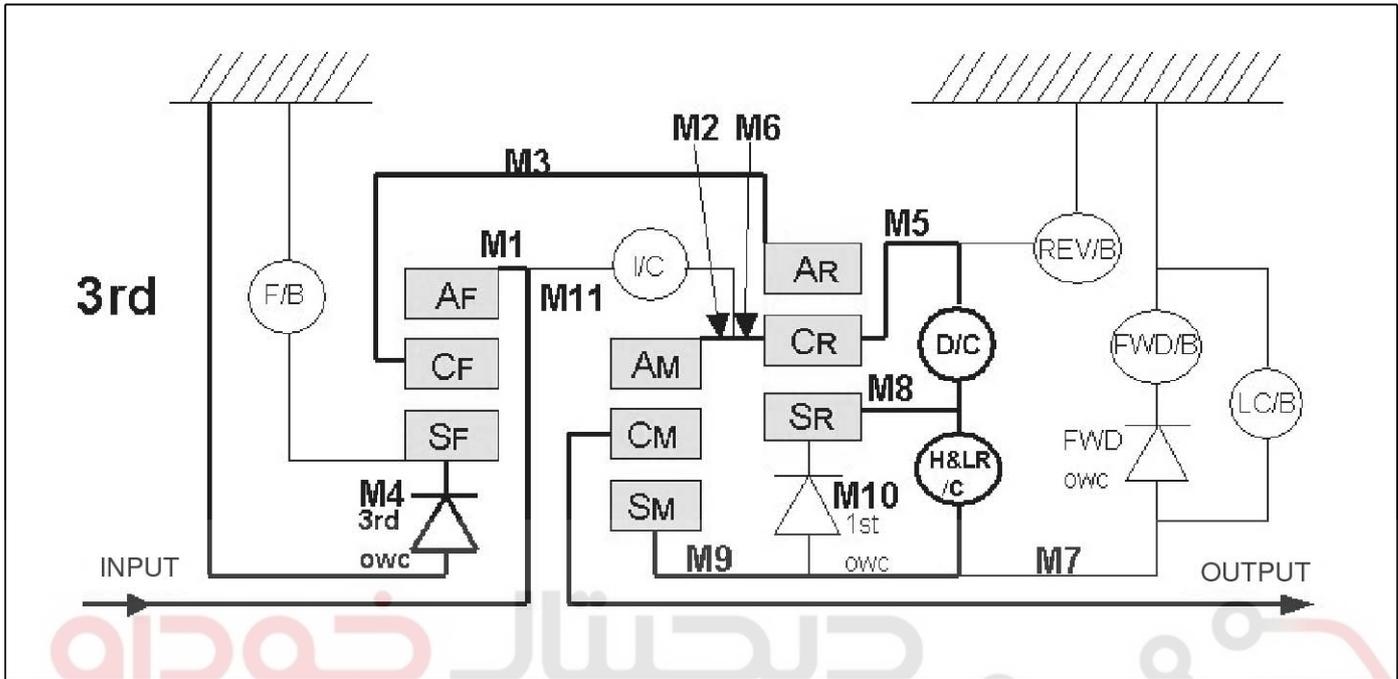
- 5. D, M3, M4, M5 range 3rd speed
 - Fastens the front brake.
 - The 3rd one-way clutch regulates reverse rotation of the front sun gear.

- The high & low reverse clutch is coupled and the middle and rear sun gears are connected.

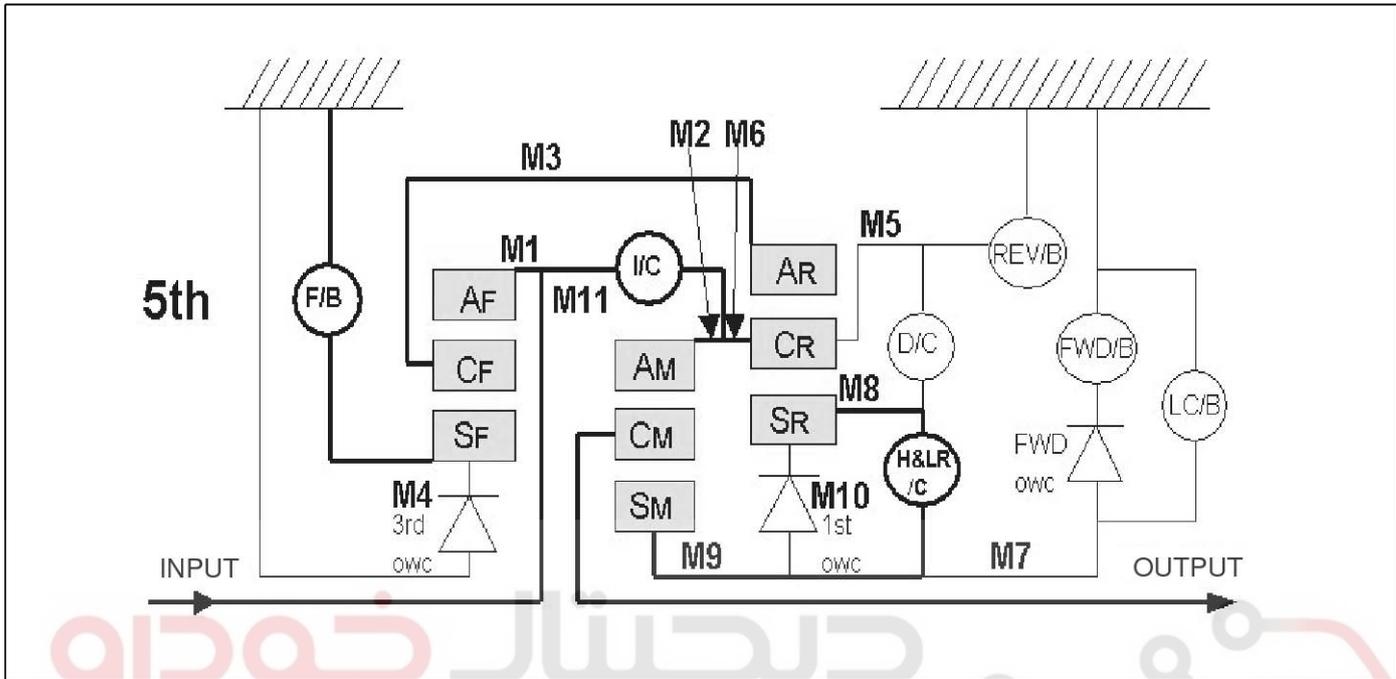
LLAE002E

7. D, M5 range 5th speed

- The front brake fastens the front sun gear.
- The direct clutch is released and the rear carrier and rear sun gear are disconnected.

*** POWER FLOW** (مسئولیت خودروه) شرکت دیجیتال خودرو
 Input shaft ⇒ Front internal ⇒ Front carrier ⇒ Rear internal input shaft ⇒ Middle internal ⇒ Rear carrier ⇒ Rear sun gear ⇒ Middle sun carrier ⇒ Middle carrier ⇒ Output shaft
 اولین سامانه

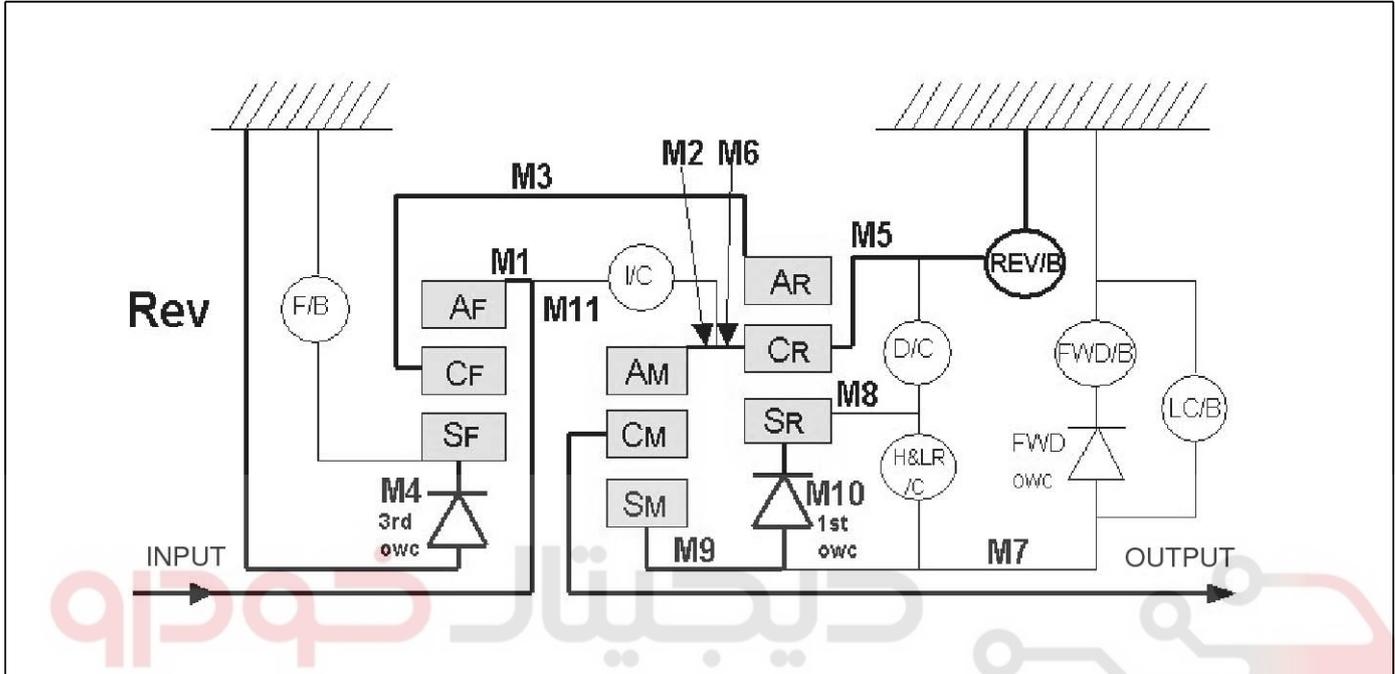
LLAE002F

8. R range

- The front brake fastens the front sun gear.
- The high & low reverse clutch is coupled and the middle and rear sun gears are connected.
- The reverse brake fastens the rear carrier.

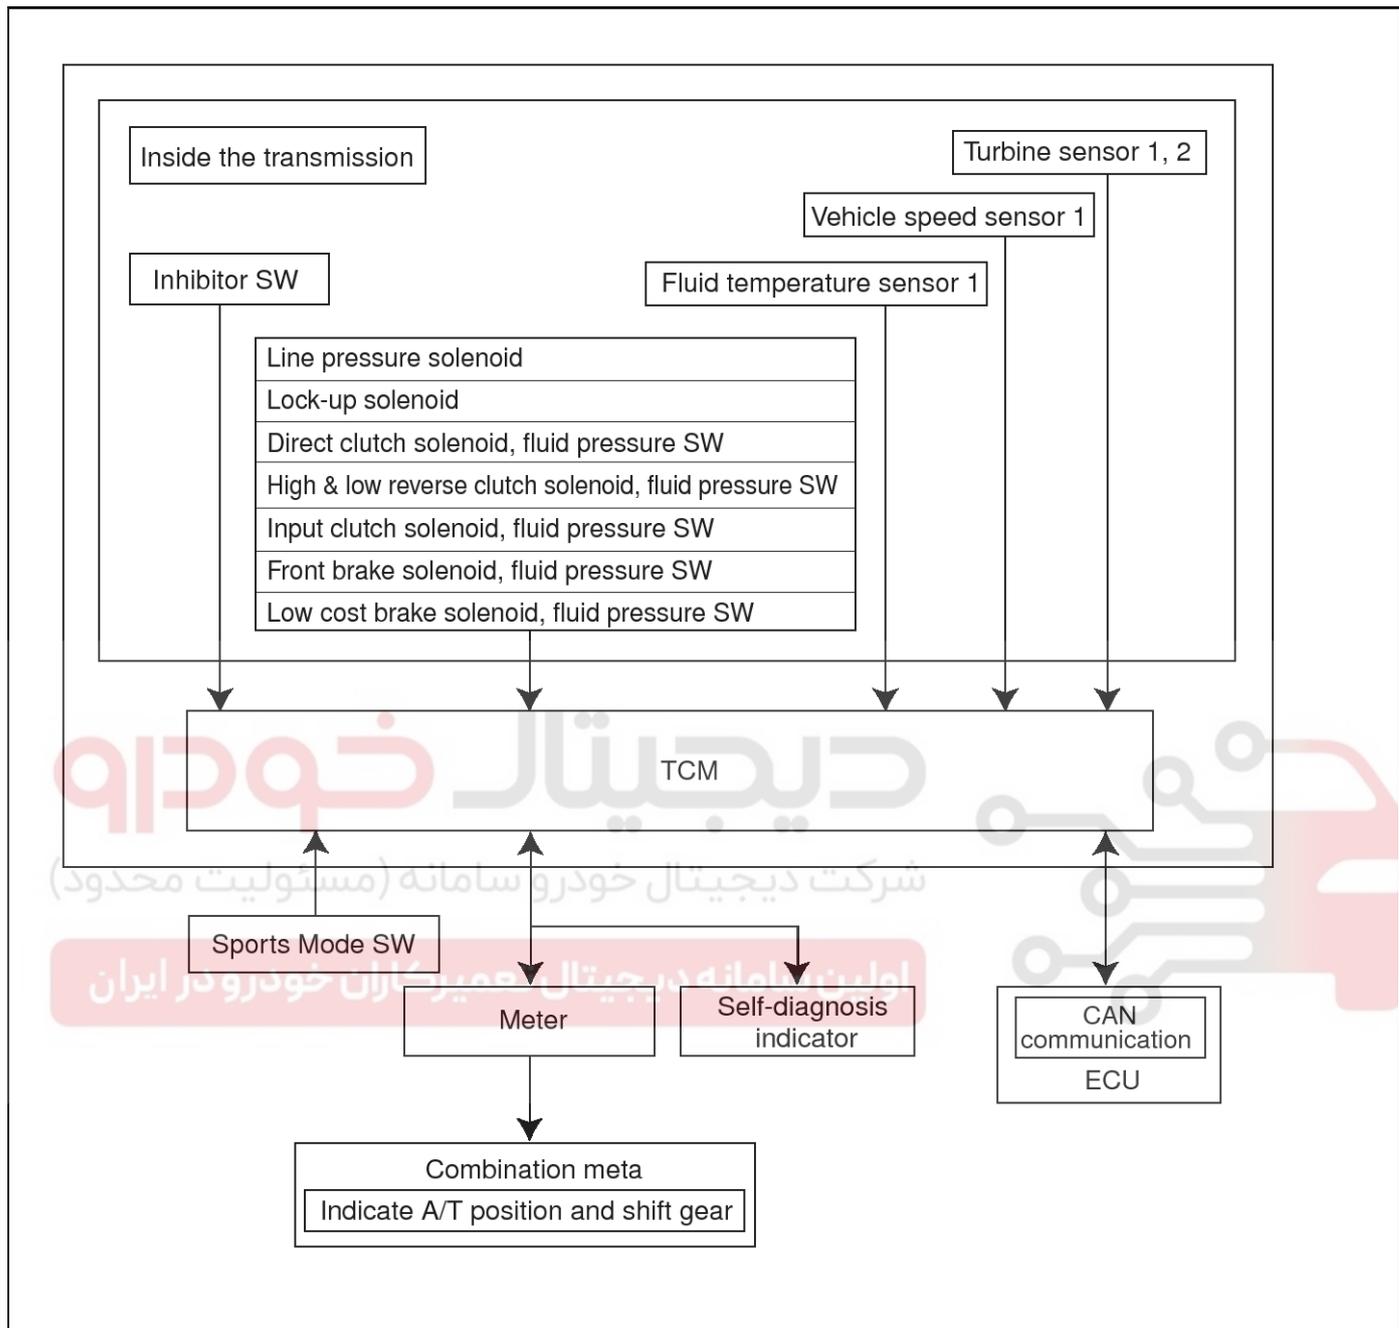
LLAE002G

CONTROL SYSTEM DIAGRAM

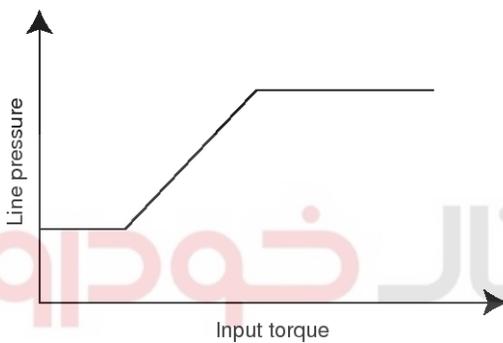
- A/T control unit (TCM) has stored in memory a number of patterns for the optimum line pressure characteristics according to driving conditions.
- In order to obtain the most appropriate line pressure characteristic to meet the current driving state, the TCM controls the line pressure solenoid current valve and thus controls the line pressure.
 - Normal line pressure control.
Each clutch is adjusted to the necessary pressure to match the engine drive force.

Normal time line pressure characteristic

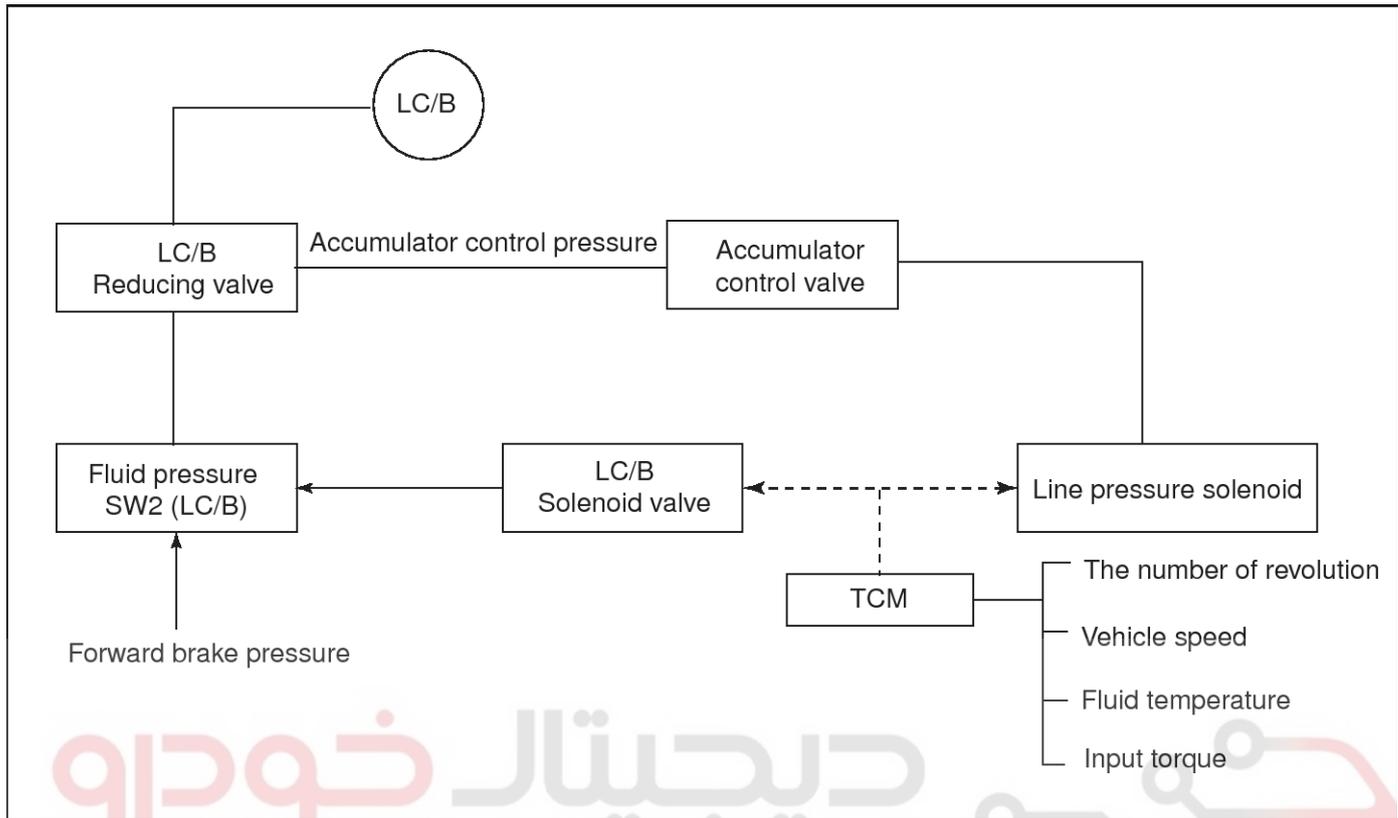
LLAE002P

ENGINE BRAKE CONTROL SYSTEM DIAGRAM

- The operation of the low coast brake solenoid switches the low coast brake switch valve and controls the coupling and releasing of the low coast brake. The low coast brake reducing valve controls the low coast brake coupling force.

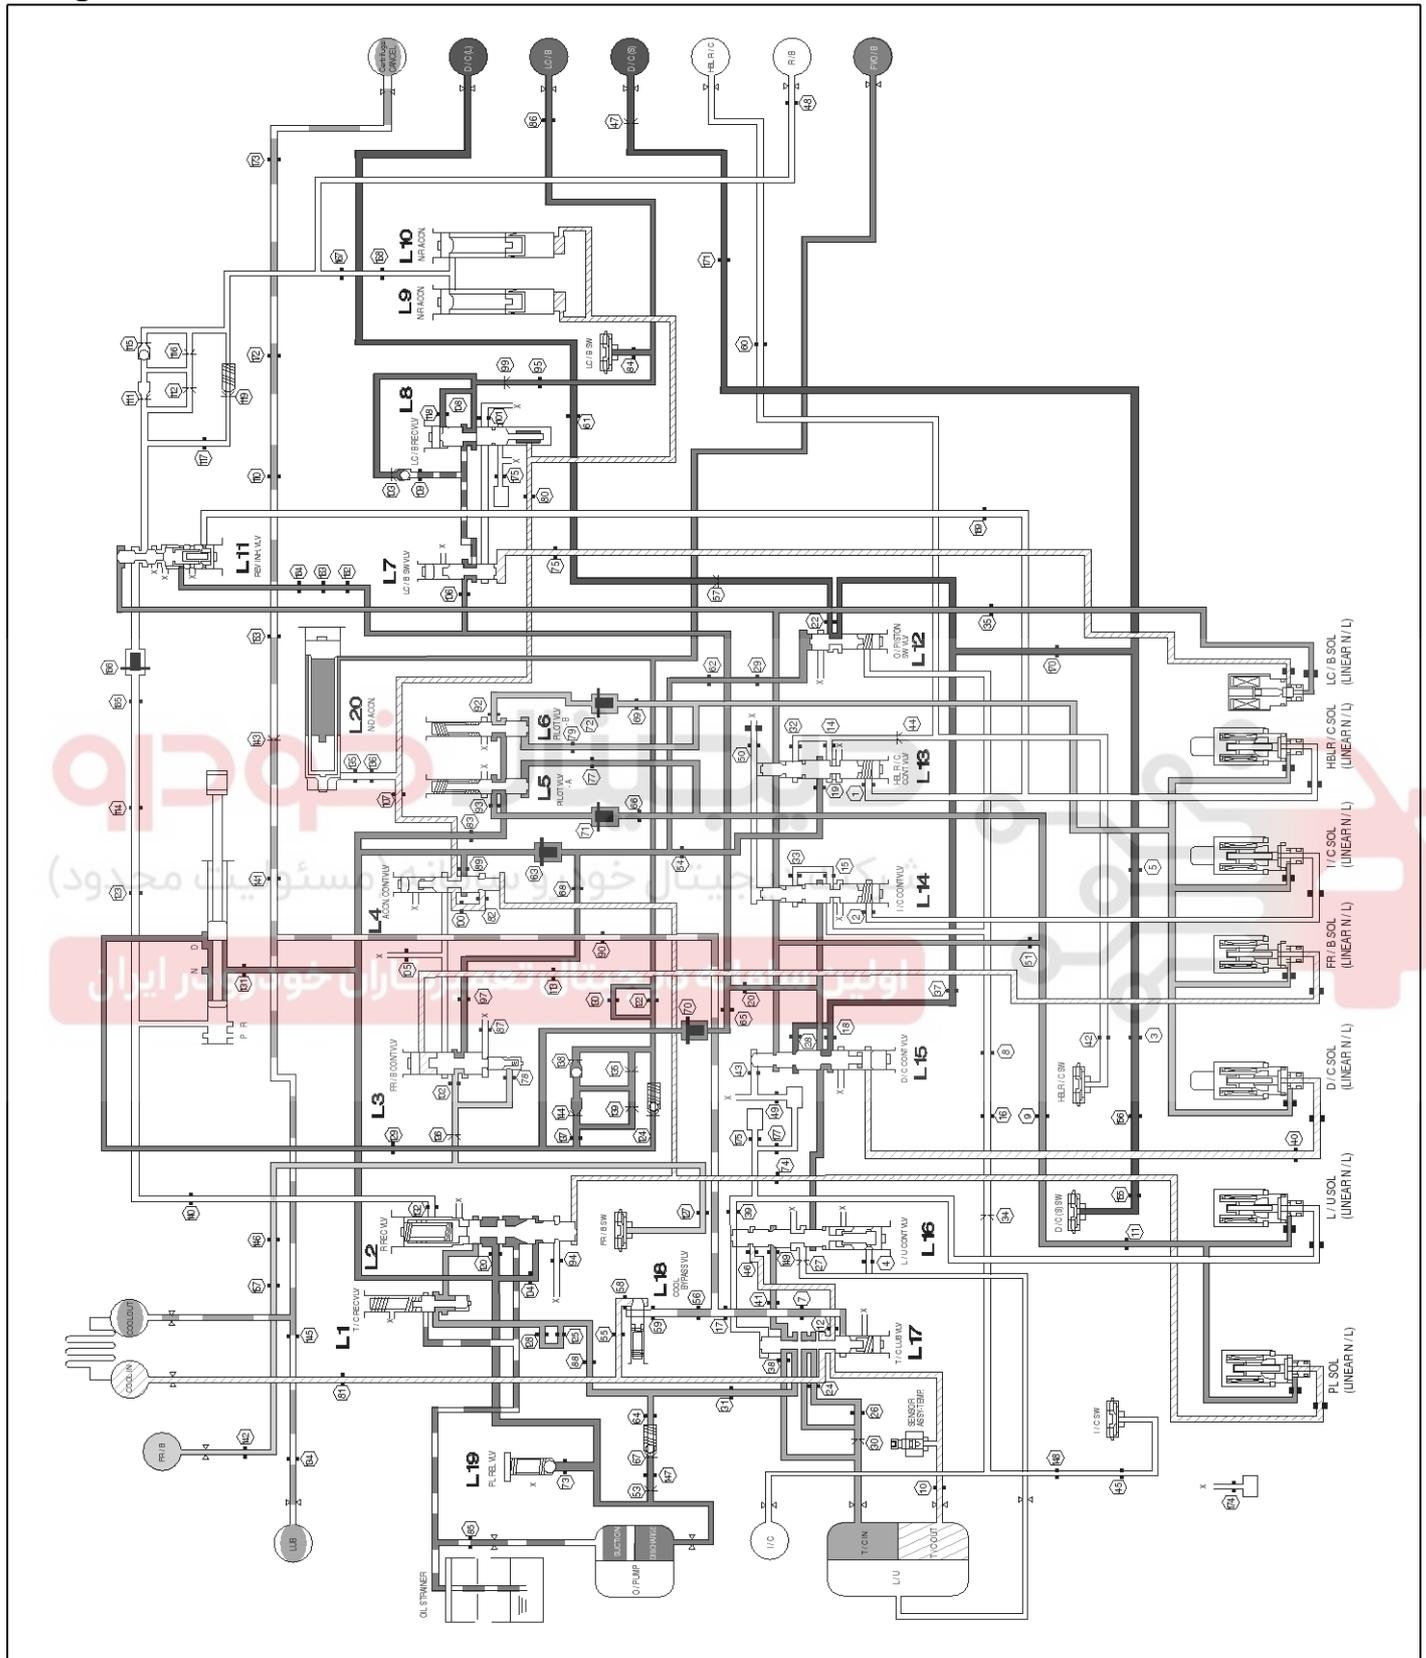
LLAE006C

2nd gear

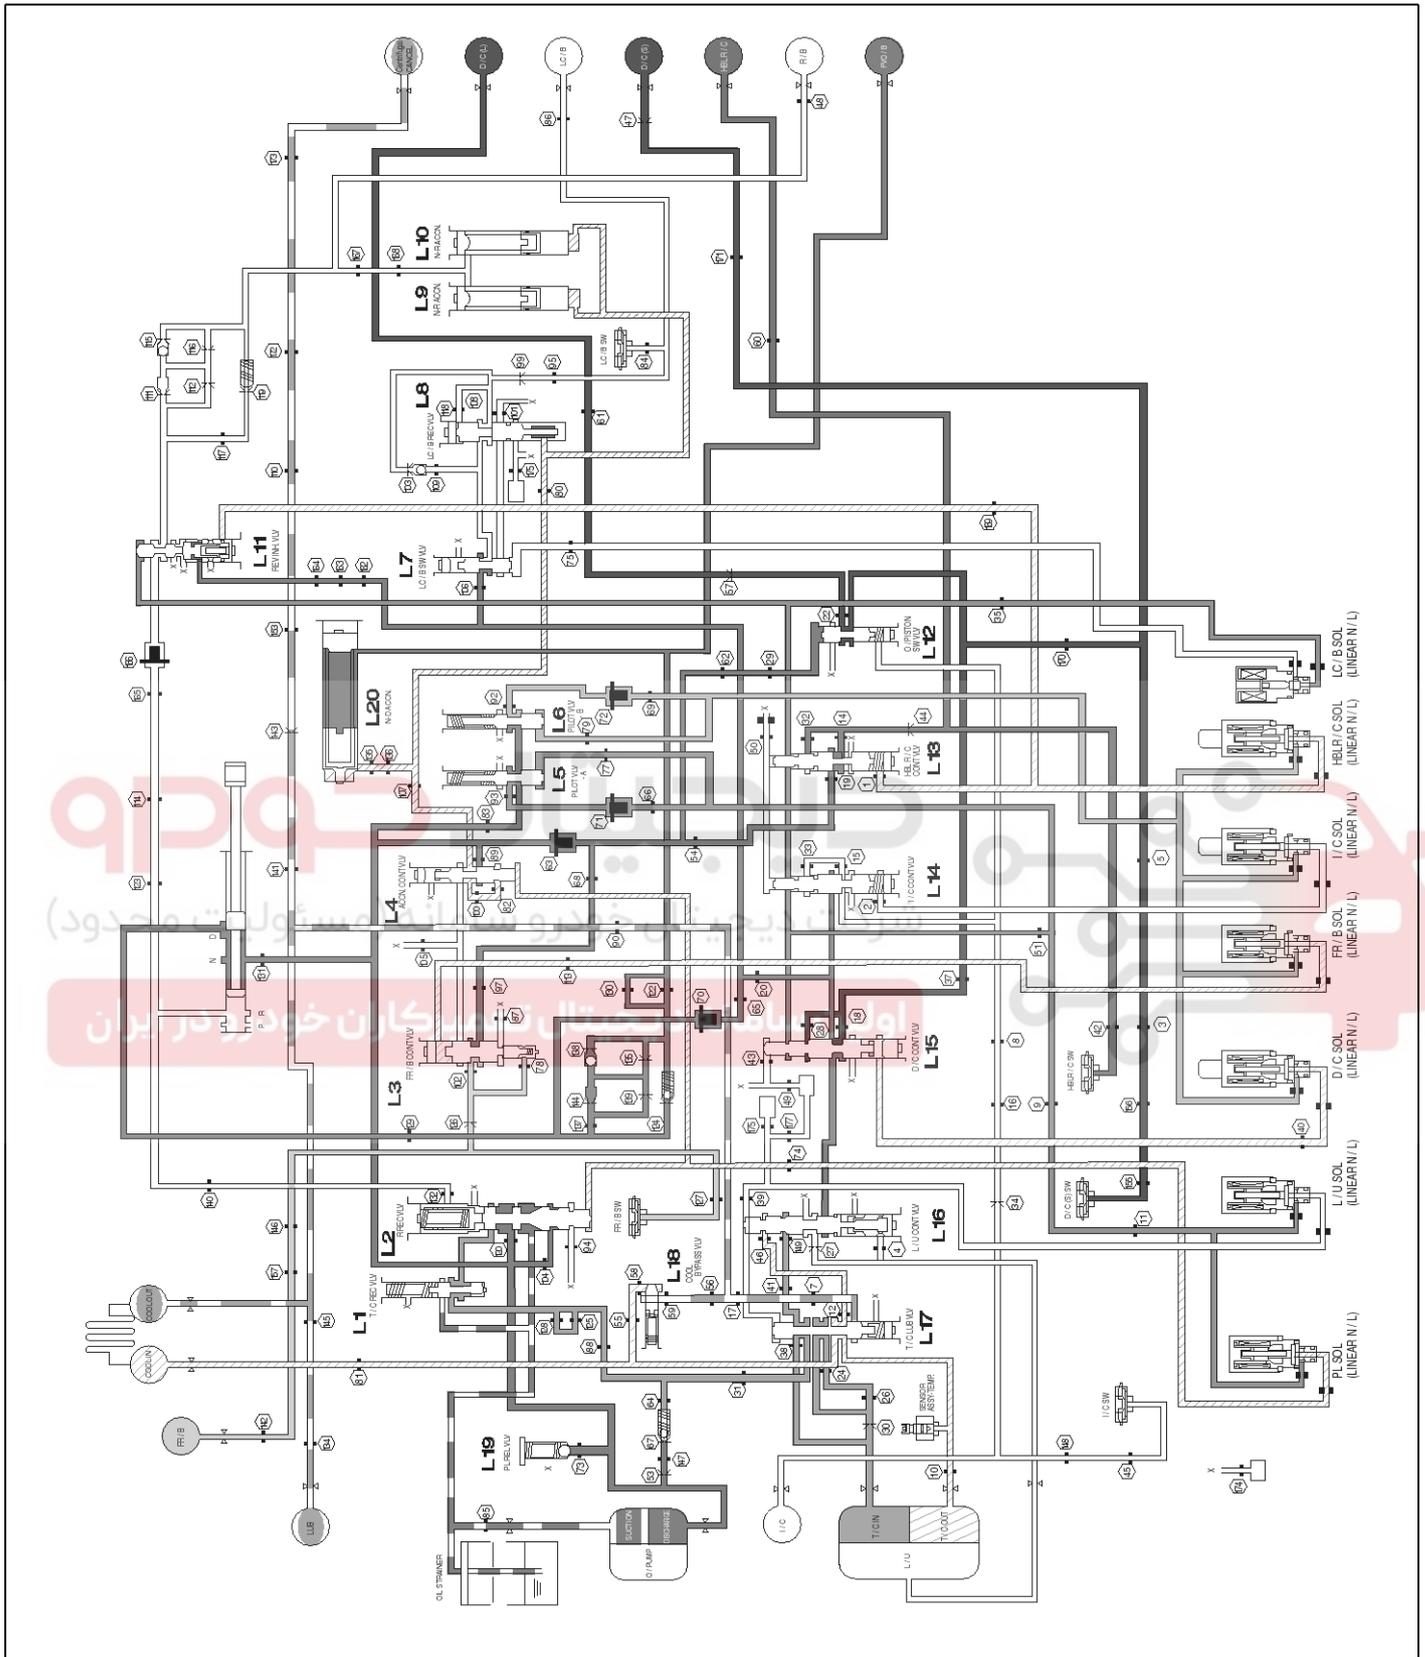
LLAE006D

3rd gear

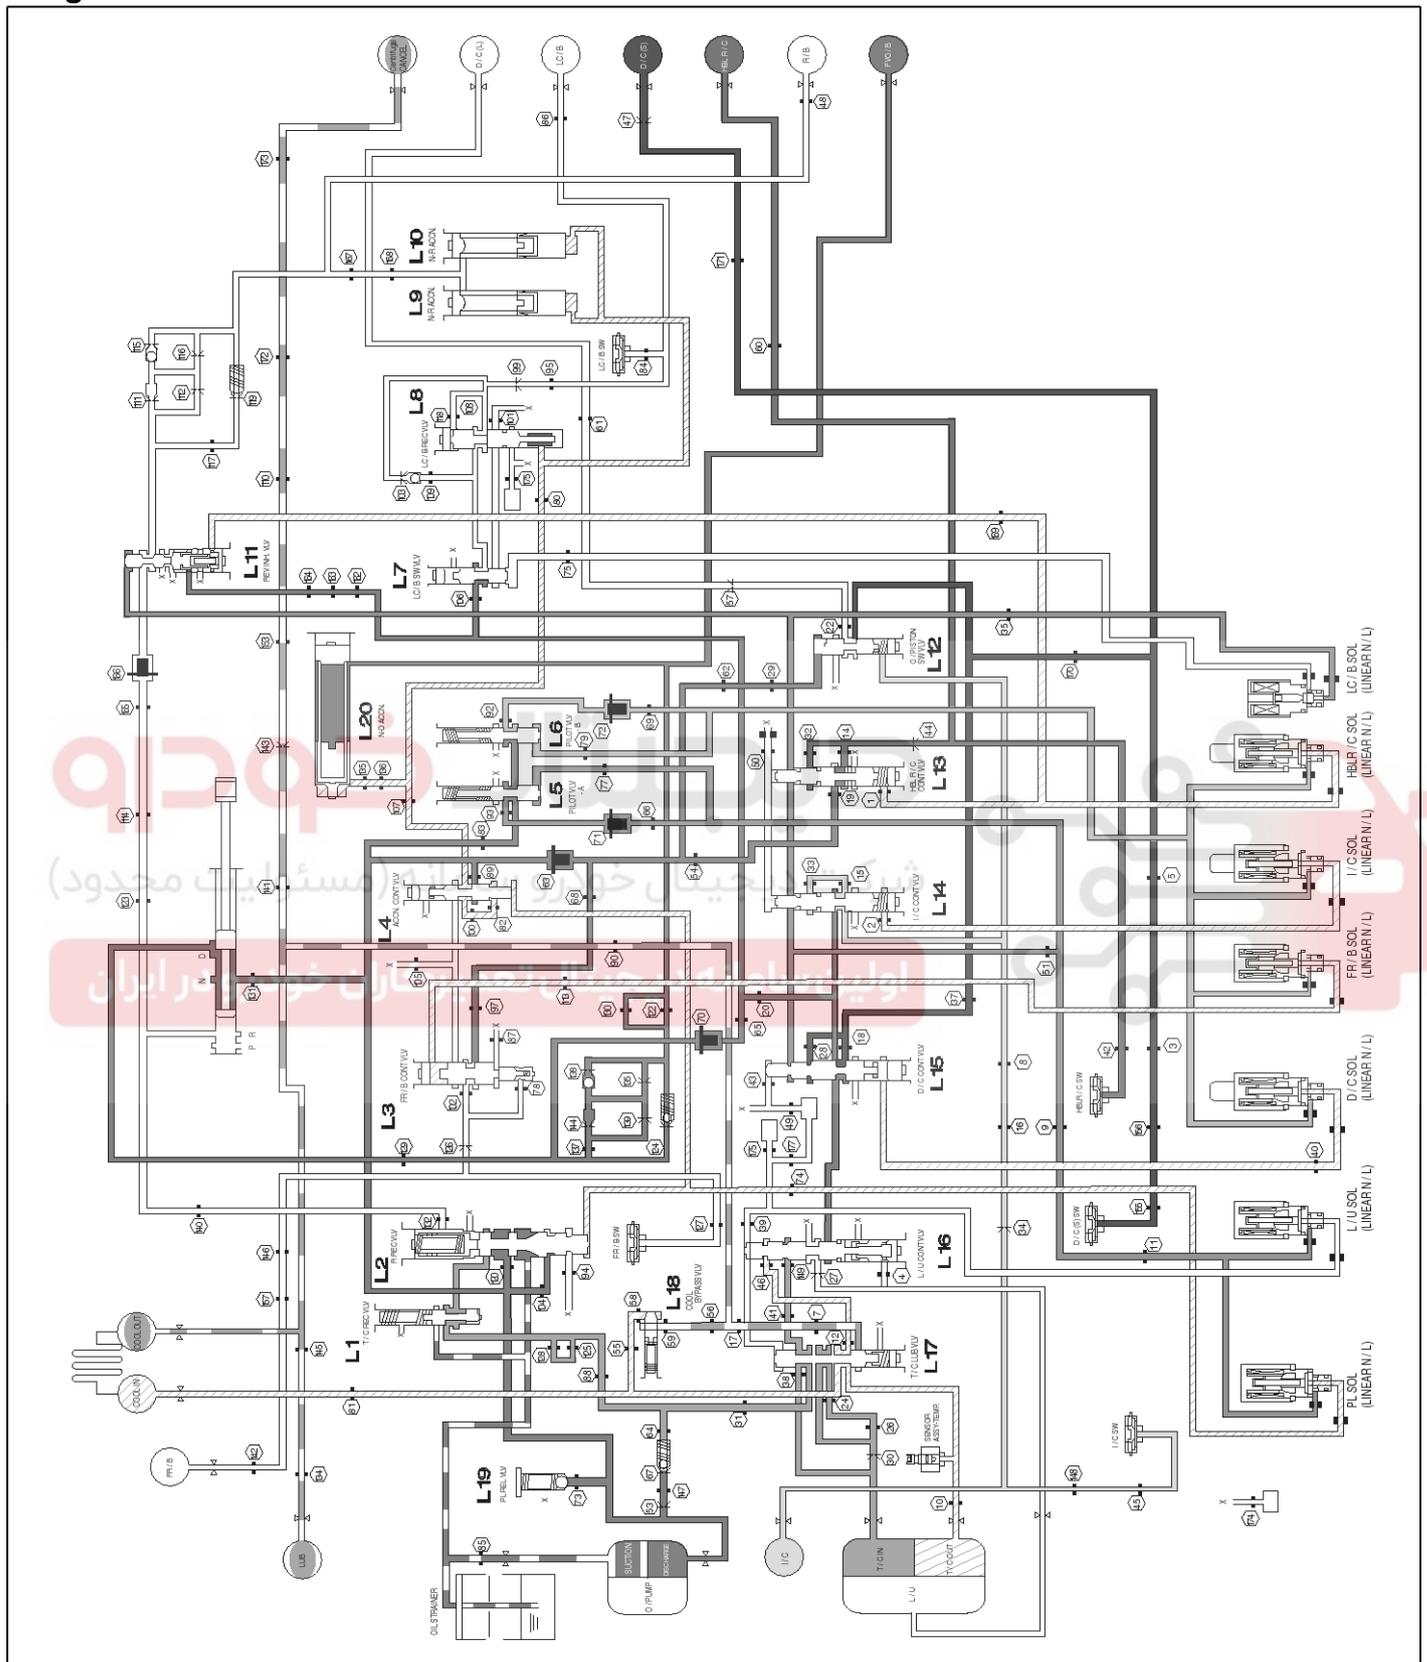
LLAE006E

4th gear

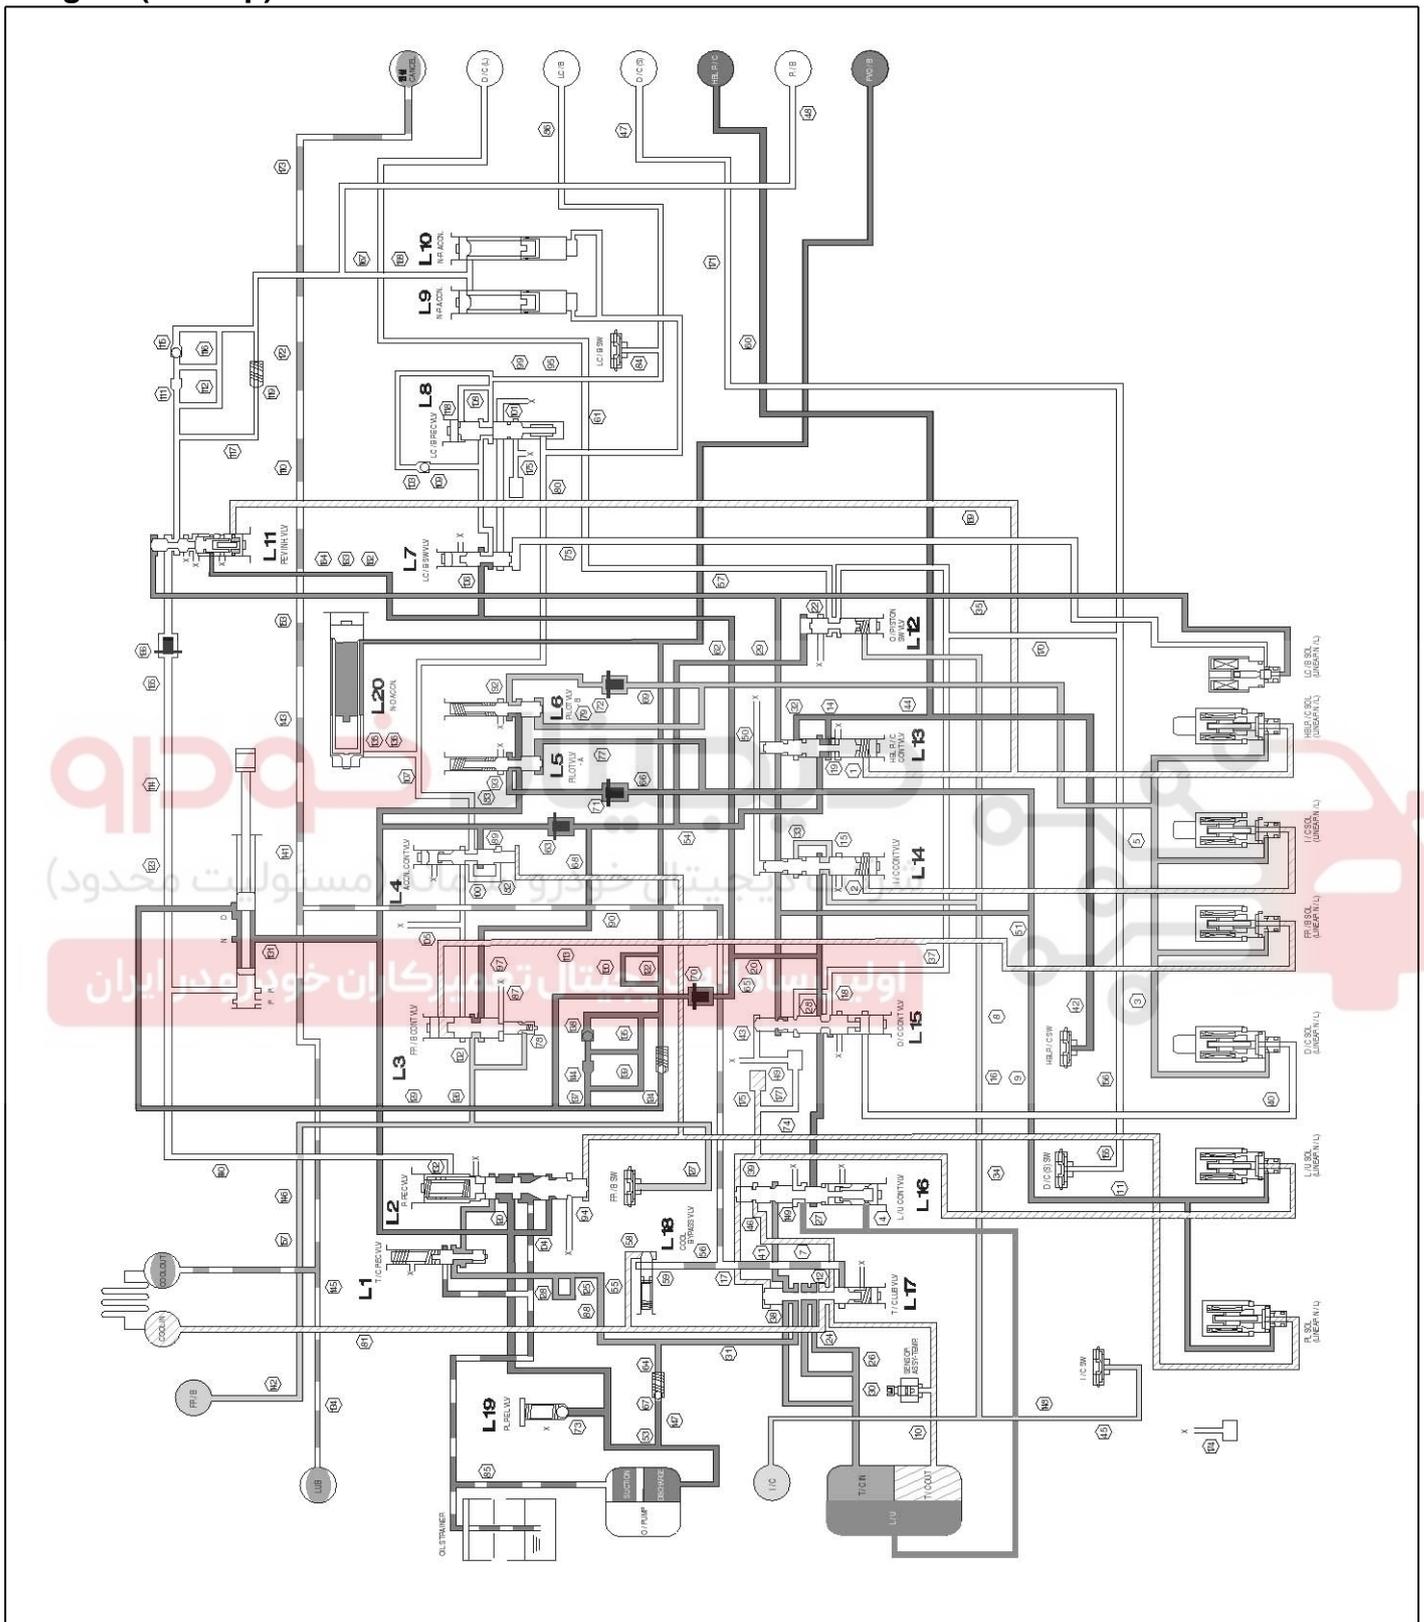
LLAE006F

5th gear (lock-up)

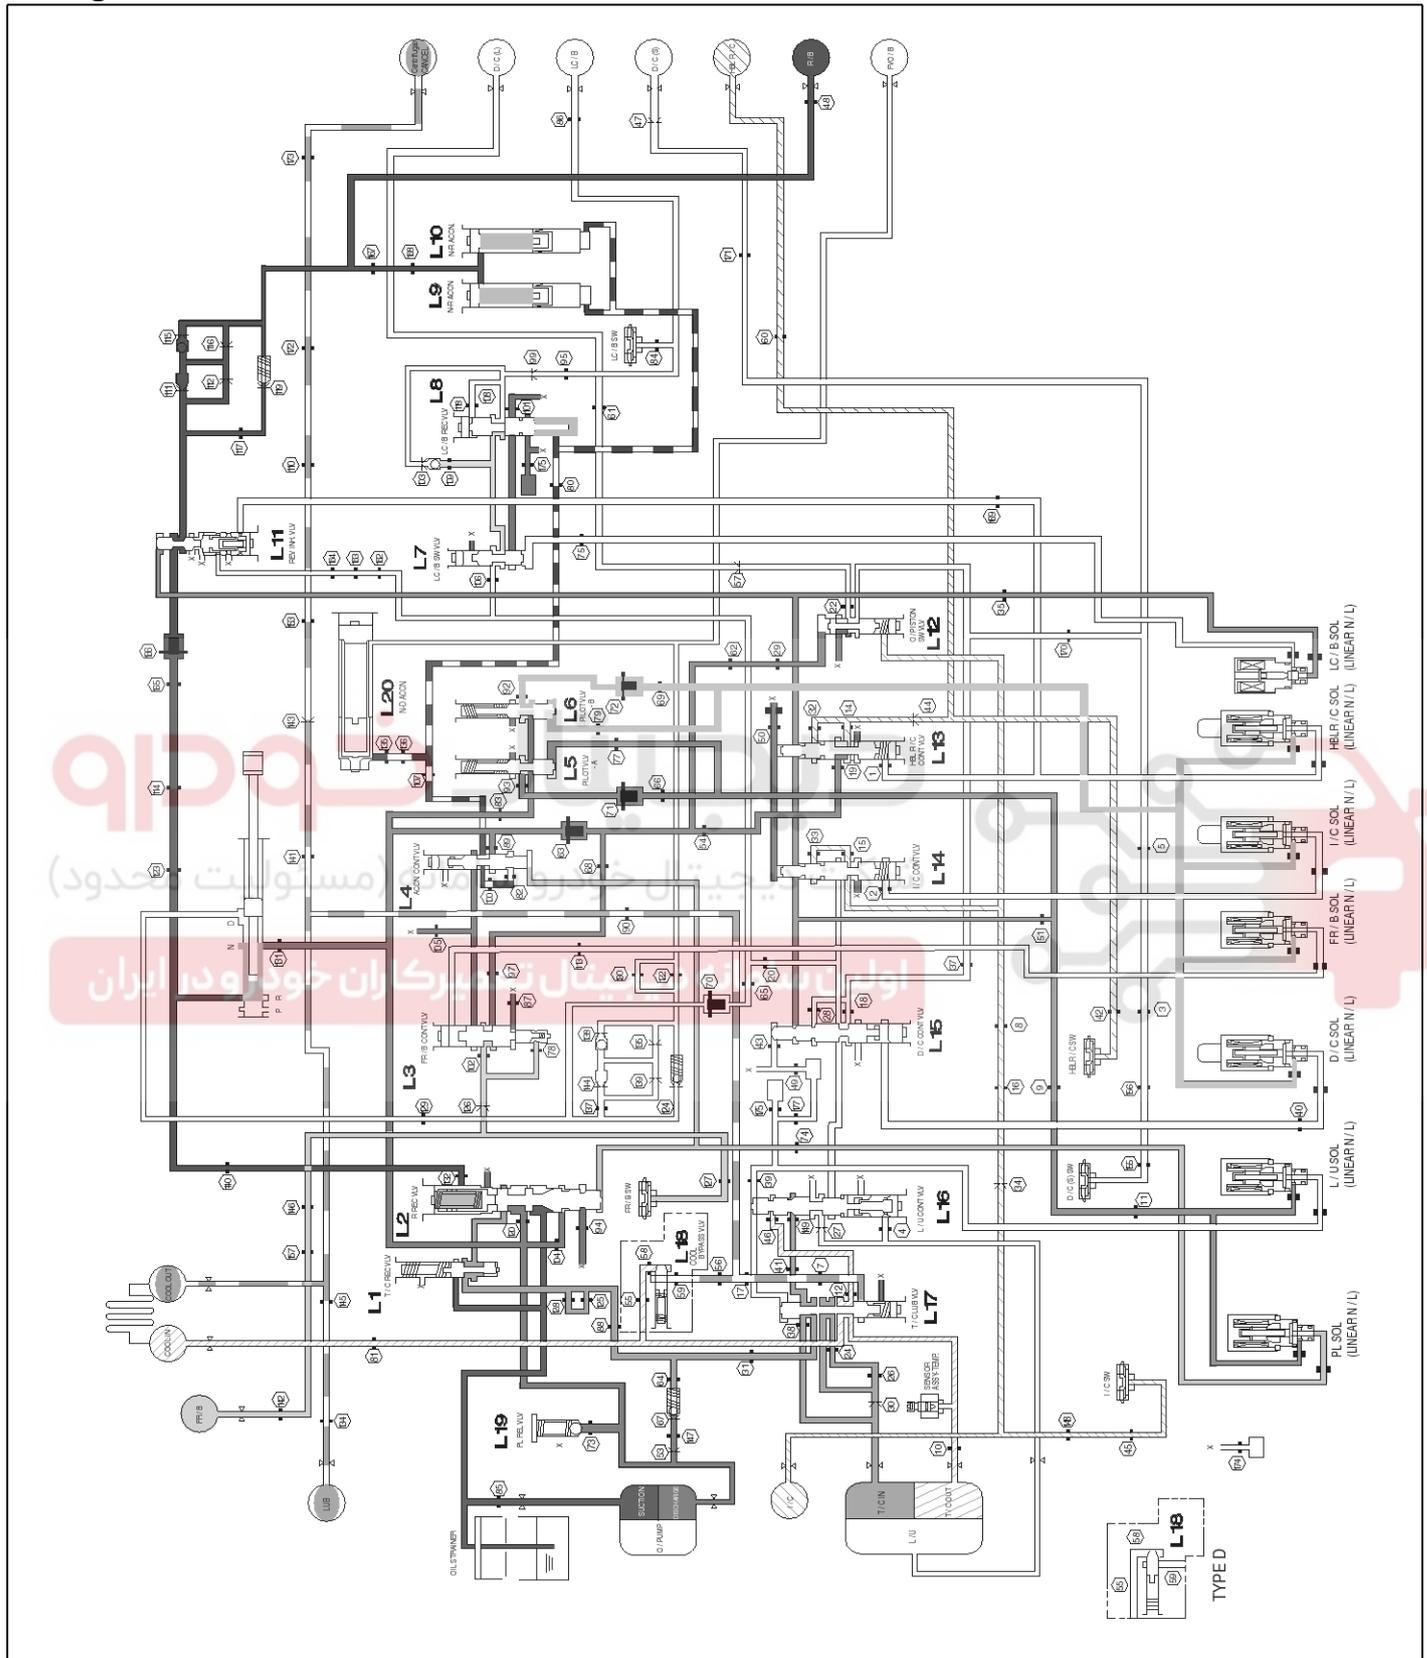
LLAE0061

R range

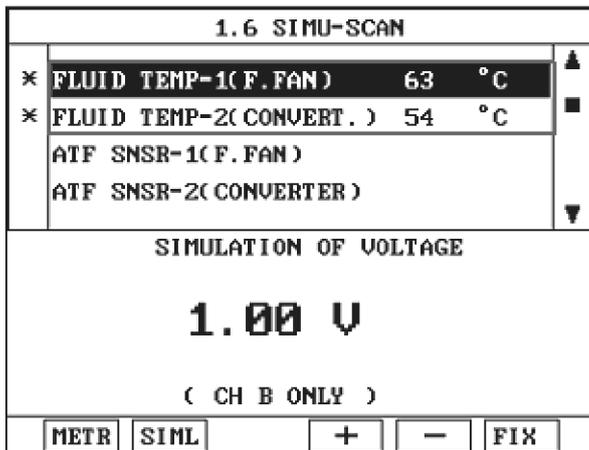
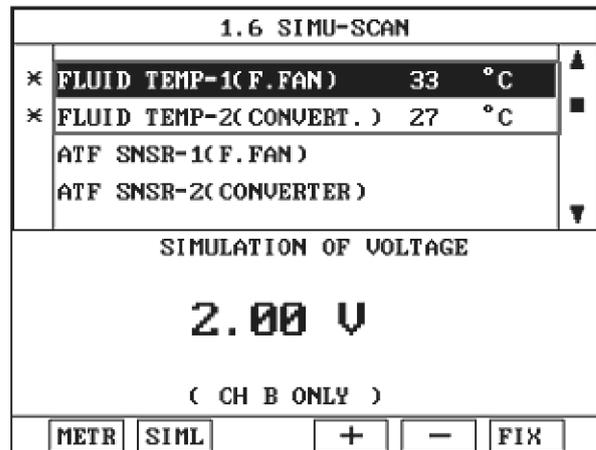
- 1) Ignition "ON" & Engine "OFF".
- 2) Disconnect the "ATF 1 [C06-1/C106-1]" connector.
- 3) Install scantool and select a SIMU-SCAN.
- 4) Simulate voltage (0→5V) to "TRANSMISSION FLUID TEMPERATURE SENSOR 1, 2" signal circuit.

FIG.1) INPUT 1.02V → 63°C
FIG.2) INPUT 2.00V → 33°C
