Automatic Transaxle System

General Information

A5SR2

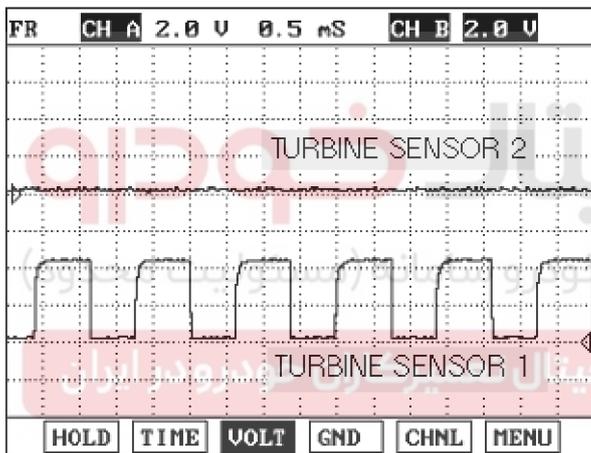
Signal Waveform

FIG.1) 1GEAR
FIG.2) 4 GEAR

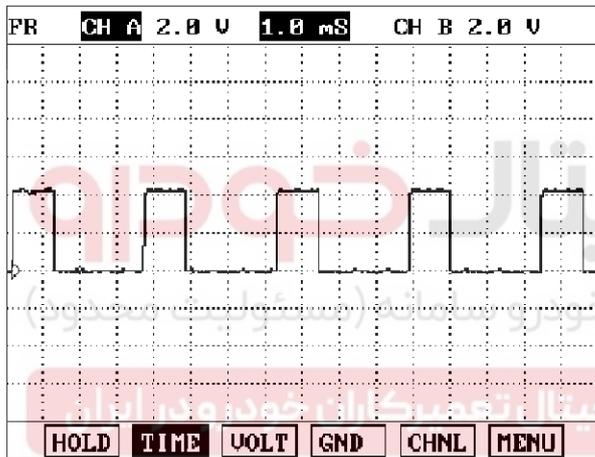
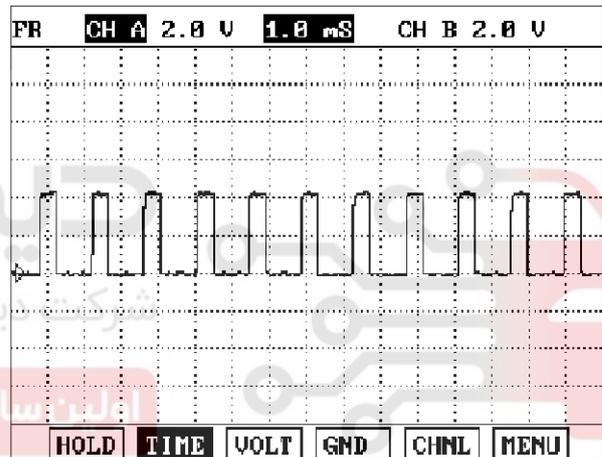
Signal Waveform

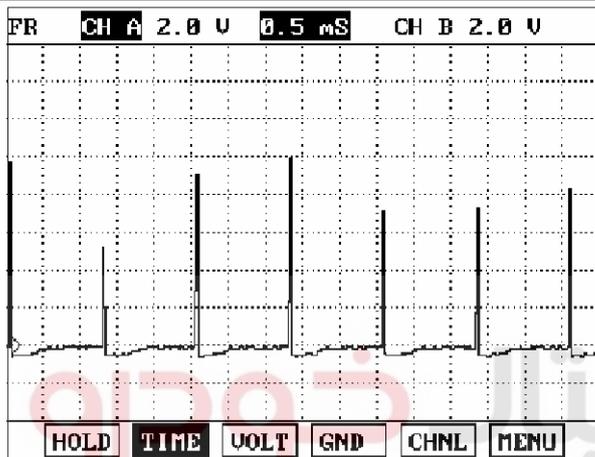
Signal Waveform

FIG.1) R RANGE

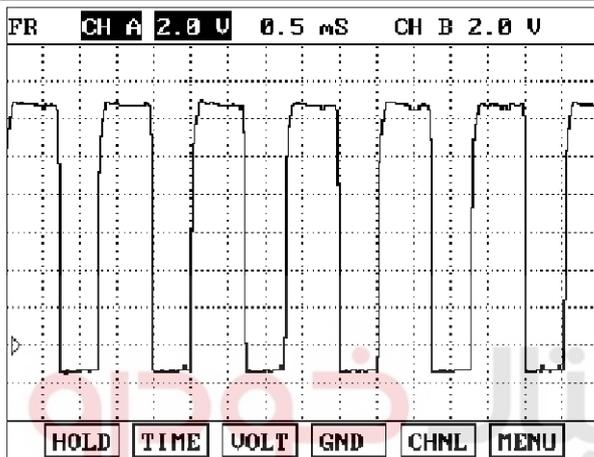
Signal Waveform

FIG.1) N RANGE

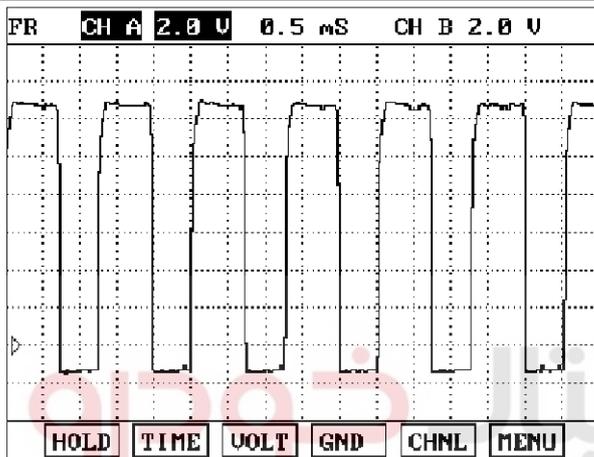
Signal Waveform

FIG.1) 2 RANGE

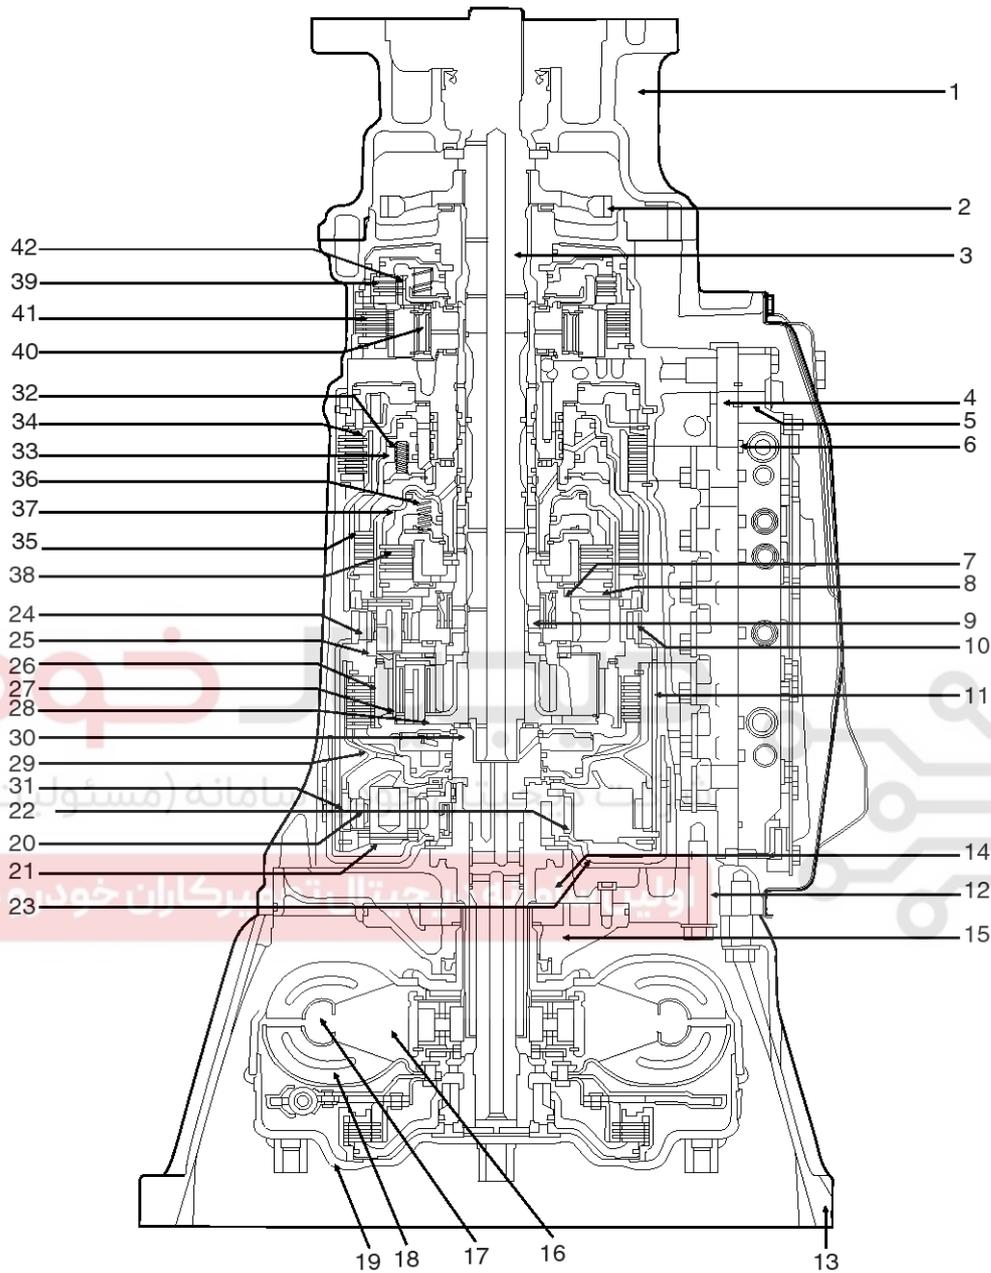
Automatic Transaxle COMPONENTS

| 1. Adapter case (4WD) | 15. Oil pump housing | 29. Input clutch drum |
